Security Barriers and Defensive Use of Space

Belfast Interfaces

Belfast Interface Project

2011

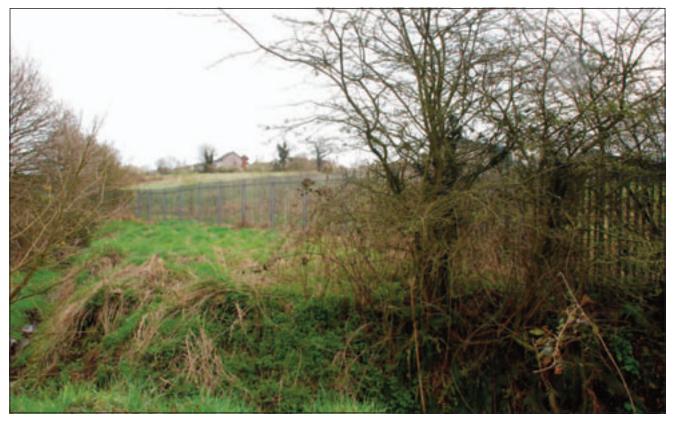
1. Suffolk Park Playing Fields - Colin Valley Golf Course (Owner: Colin Valley Golf Course):
A 2 metre high mesh fence runs along the boundary of Colin Valley Golf Course, adjacent to the Arlington housing development.

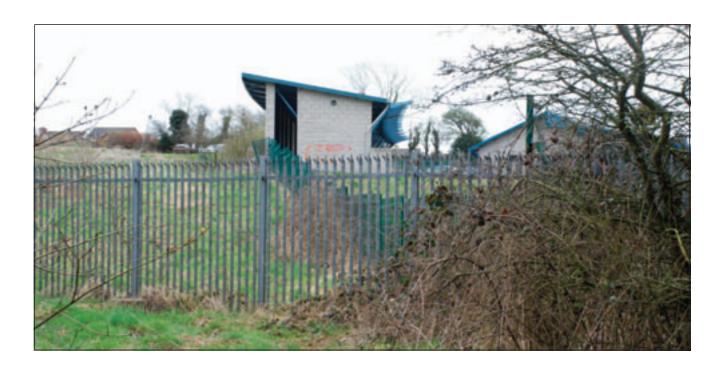
2. Carnanmore Park (Owner: NIHE. Built: 1980s): A 2 metre high fence runs for 600 metres from close to the junction of Stewartstown Road between rear of houses in Carnanmore Park and the Glen River.

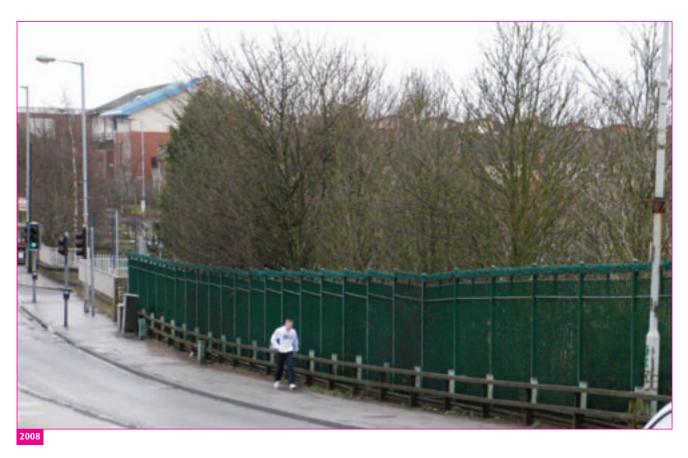
Stewartstown Road, Suffolk (Owner: Unknown. Built: 1970s): A metal fence with barbs on top begins next to barrier No. 2. It runs up a bank to Stewartstown Road and along the edge of the road before turning right beside a footpath which leads to houses in Carnanmore Park.

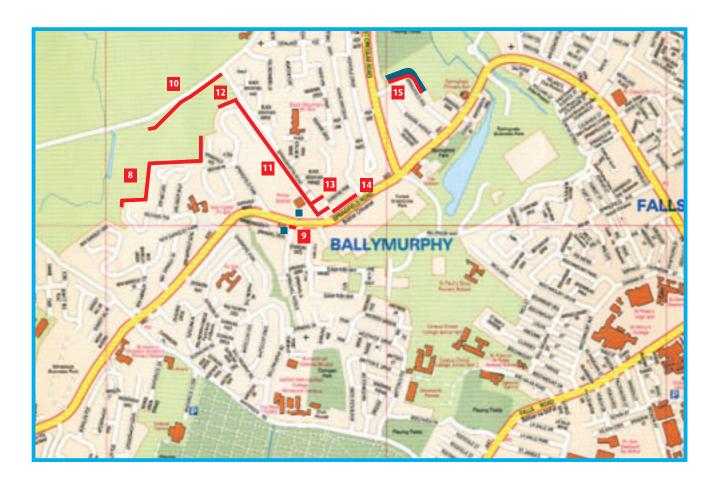
8. Moyard Parade (Owner: DoJ. Built: 1991): A palisade fence, approximately 3.6 metre high, runs for 300 metres from the rear of Moyard Parade across the rear of Moyard Crescent. It runs across the head of Springfield Park and the rear of houses at Springfield Heights. The fence separates the various properties from rough hillside and grazing land.

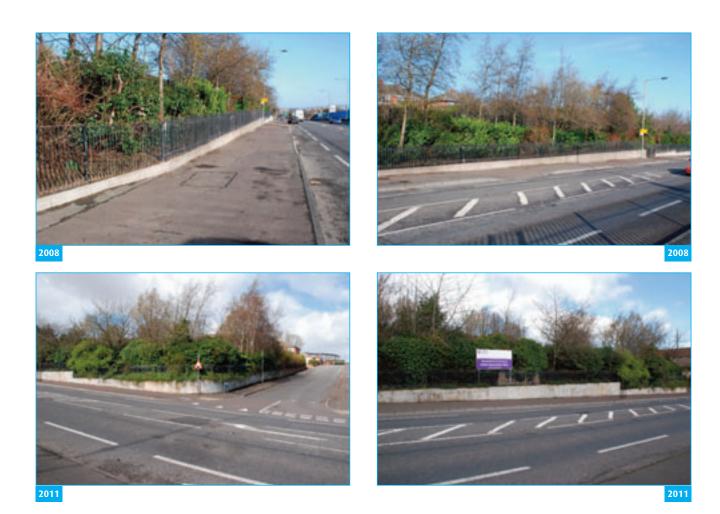
15. Springfield Parade - West Circular Road (Owner: DoJ. Built: 1980s): A 2 metre high brick wall with 4 metre high fencing above runs at the rear of properties on the West Circular Road; the barrier then turns 90 degrees and continues as a 2.1 metre high solid metal fence along the face of Springfield Parade.

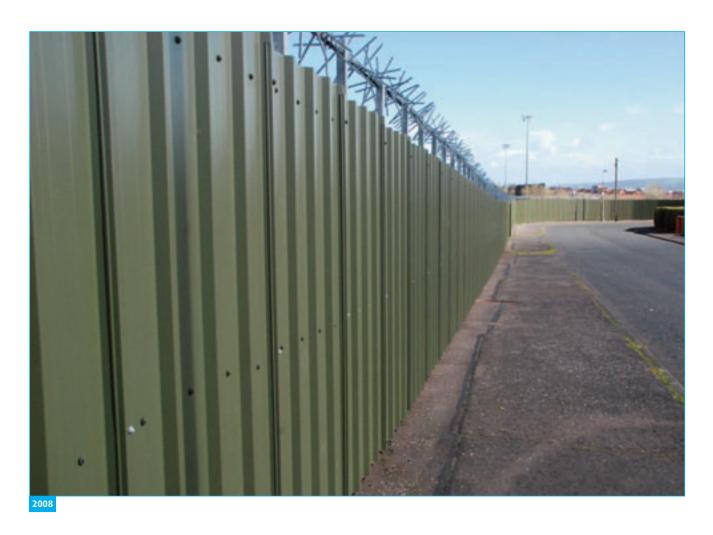
15.1. Springfield Parade: An area of unused land lies behind barrier No.15.

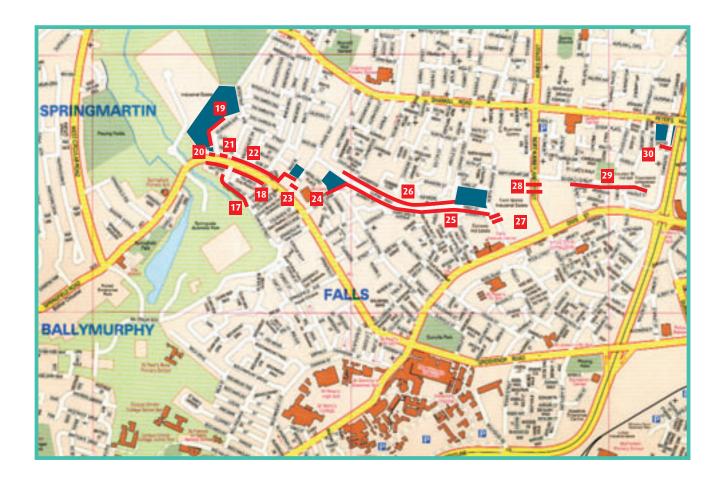
16. Springfield Road – opposite Violet Street (Owner: Unknown): A small section of sheet metal fencing sits atop a brick wall, approximately 4 metres long in a closed-off entry, opposite the site of the former Violet Street army / police base.

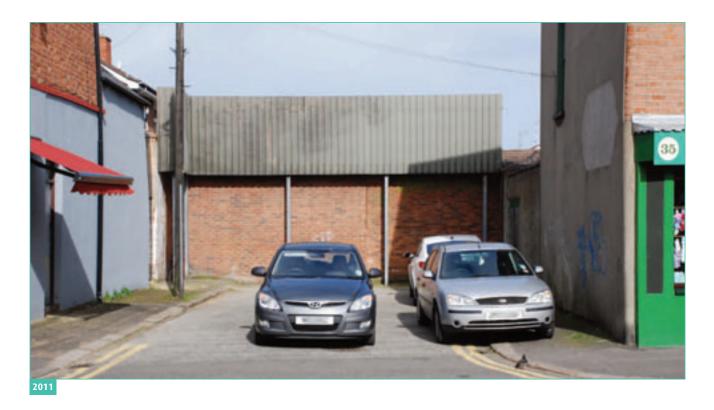
17. Elswick Street - Pollard Street (Built by NIO, handed to BMC as part of a redevelopment programme.): A palisade fence runs approximately 150 metres along on the boundary of former wasteland; it terminates at the junction with Forfar Street. The land on the other side of the fence is being redeveloped as a Belfast Metropolitan College campus.

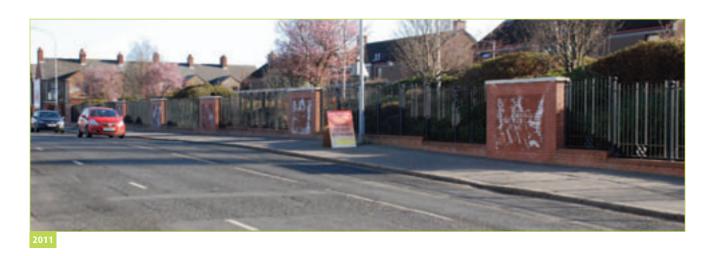
32.1 Glenmachan Street (Owner: Private): A brownfield site is advertised for sale at the junction of Glenmachan Street and the Broadway Roundabout.

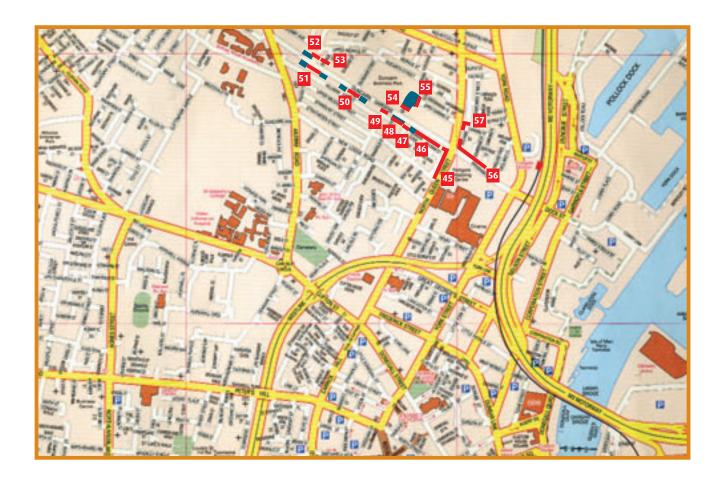
45. North Queen Street (New Lodge) (Owner: DoJ. Built: 2001): A brick wall with three levels of mesh fencing above runs in front of houses on North Queen Street between Spamount Street and Duncairn Gardens.

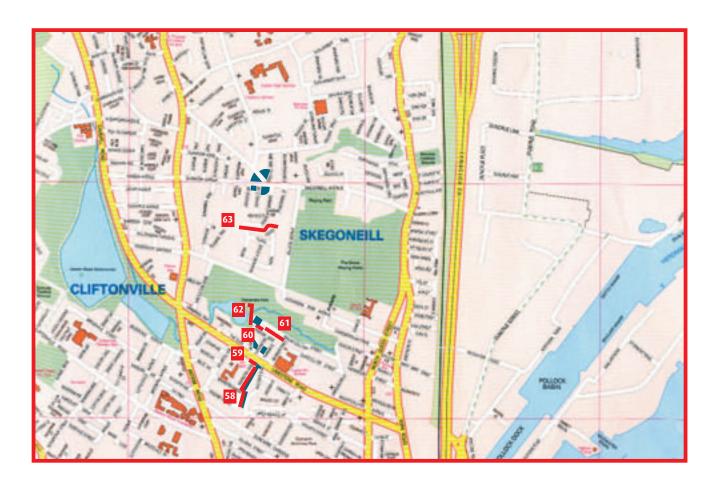
58. Hallidays Road - Newington Avenue (Owner: Doj. Built: 1999 & 2003): A 258 metre long and 5.5 metre high metal fence with a layer of mesh fencing above runs from Limestone Road to Duncairn Gardens. The fence separates properties on Newington Street and Newington Avenue from properties on Hallidays Road in Tigers Bay. There is a further short section of mesh fence, 3 metres wide and 5.5 metres high between the first two properties on the corner of Limestone Road, erected in 2003.

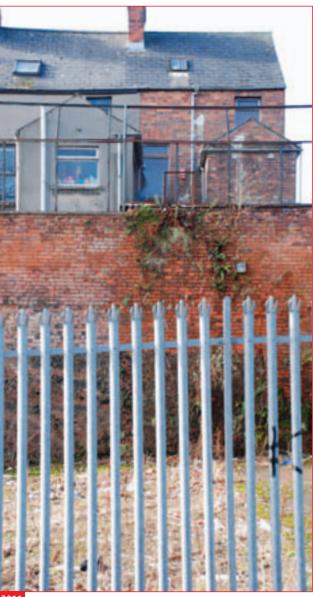
62. Alexandra Park (Owner: DoJ. Built: 1994 & 1990s): A sheet metal fence, 120 metres long and 3.5 metres high, runs across Alexandra Park from Parkside Gardens to the rear of the recycling depot on Alexandra Park Avenue. This is effectively a continuation of the barrier between Mountcollyer and Parkend Street. A newly installed gate on the fence was opened in September 2011 as part of a pilot project during which the gate would be open 9.00am – 3.00pm on weekdays for a three month period after, which the opening times would be reviewed with full consultation.

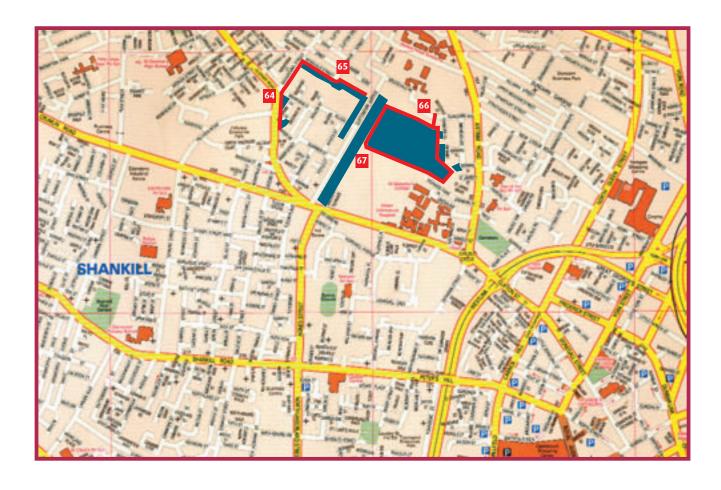
64. Oldpark Road - Rosapenna Street (Owner: DoJ. Built: 1980s): A 4 metre high brick wall with 4 metre high sheet metal fencing above runs for 100 metres at the rear of houses in Rosapenna Street and Mountview Court. A further section of the barrier includes a mix of palisade fencing and brick wall running along the boundary of Oldpark Road and Mountain View Court.

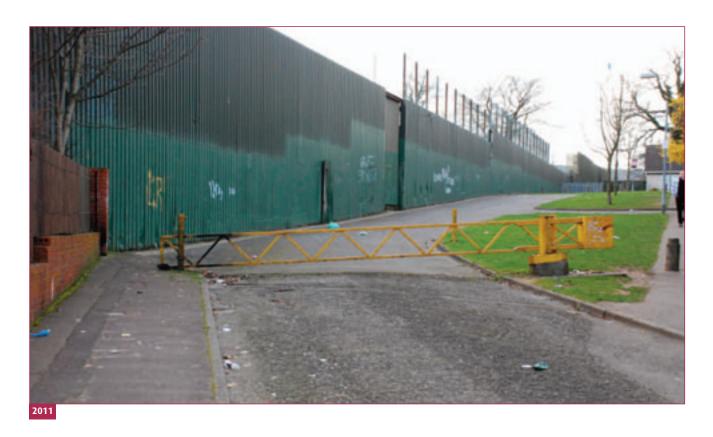
66. Brucevale Park - Duncairn Avenue (Owner: DoJ. Built: 1978): A pair of low-level, double swing arm, steel security gates closes off access between these two streets, which run along the boundary of the former Girdwood barracks.

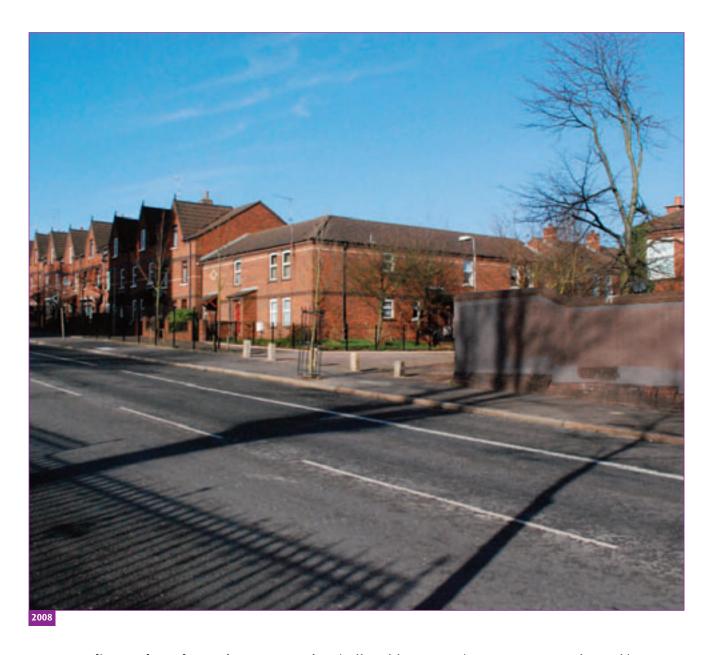
71. Crumlin Road - Ardoyne (Owner: NIHE): A buffer of fencing and vegetation sits in front of houses from Butler Walk to Kerrera Street.

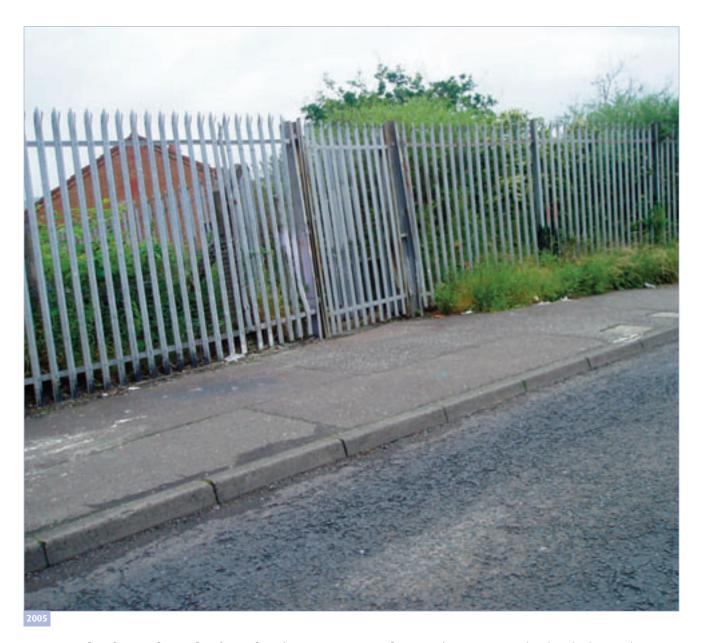
87. Longlands Road – Arthur's Bridge (Owner: DoJ. Built: 1998): A section of palisade fence closes off a pedestrian entry and adjacent land at Arthur's Bridge. Access to the footpath has been further restricted following the rebuilding of Arthur's Bridge.

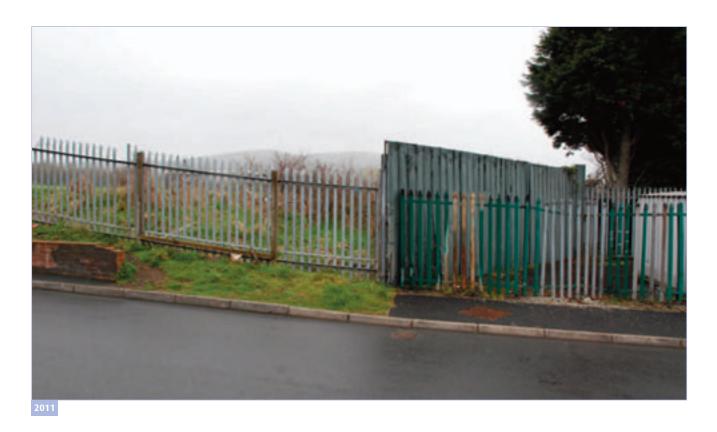
88. Longlands Avenue (Owner: DoJ. Built: 1990s): A palisade fence with sheeting above, 30 metres long and 3 metres high, divides Longlands industrial estate from playing fields adjacent to Valley Leisure Centre.

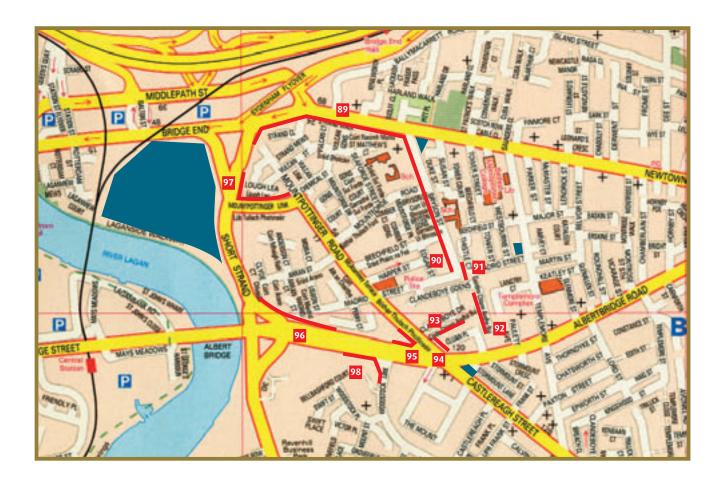
89. Lower Newtownards Road - Strand Walk (Owner: Doj. Built: 1980s & 2003): A brick wall, 3 metres high, with intermittent sections of fencing between runs for 200 metres between Strand Walk and Lower Newtownards Road. The wall runs from the chapel grounds and follows the line of the road into Short Strand. The barrier prevents vehicle access between Mountpottinger Road and Bridge End, but pedestrian access remains.

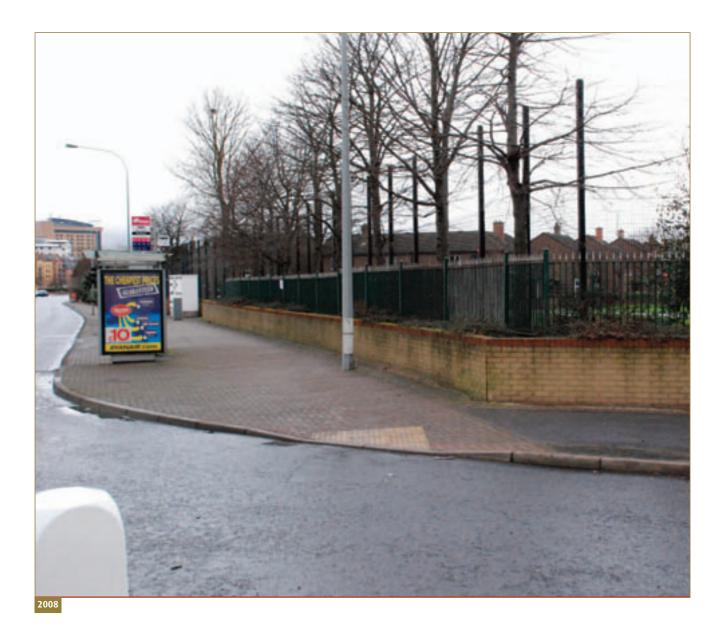
95. Mountpottinger Road - The Green (Owner: DoJ, NIHE maintained.): An open public space is bounded on the Albertbridge Road & Mountpottinger Road sides by a 5 metre high mesh steel fence.

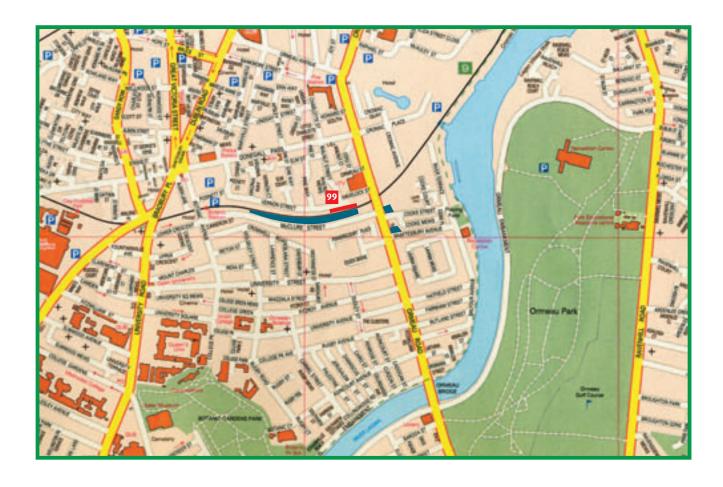
99. Vernon Street (Owner: NIHE): A 4m high steel mesh fence above a brick wall beside number 71 Vernon Street.
